Technical Report

**CORROSION OF MATERIALS
IN HYDROSPACE**

U. S. NAVAL CIVIL ENGINEERING LABORATORY
Port Hueneme, California

Technical Report R-504

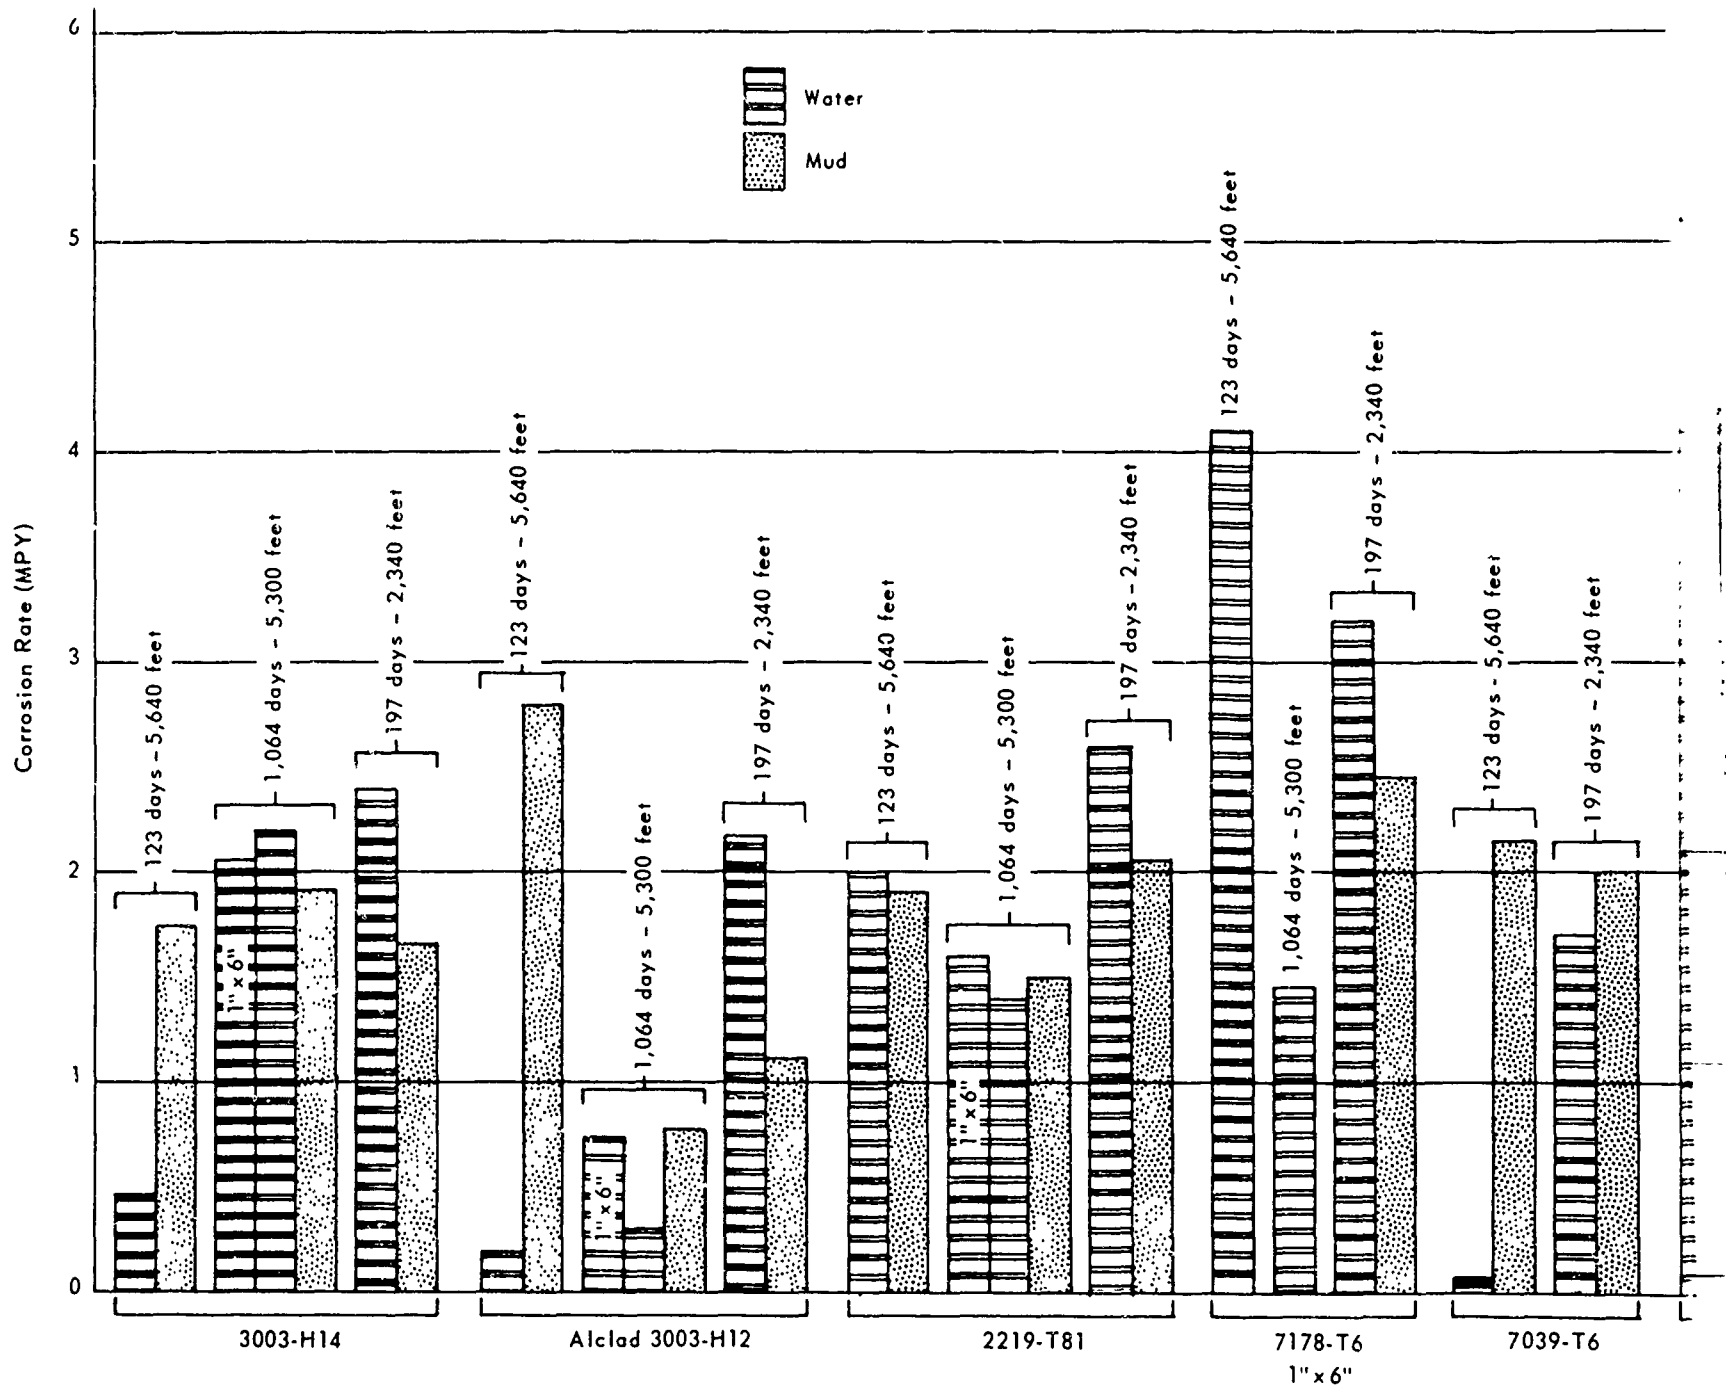
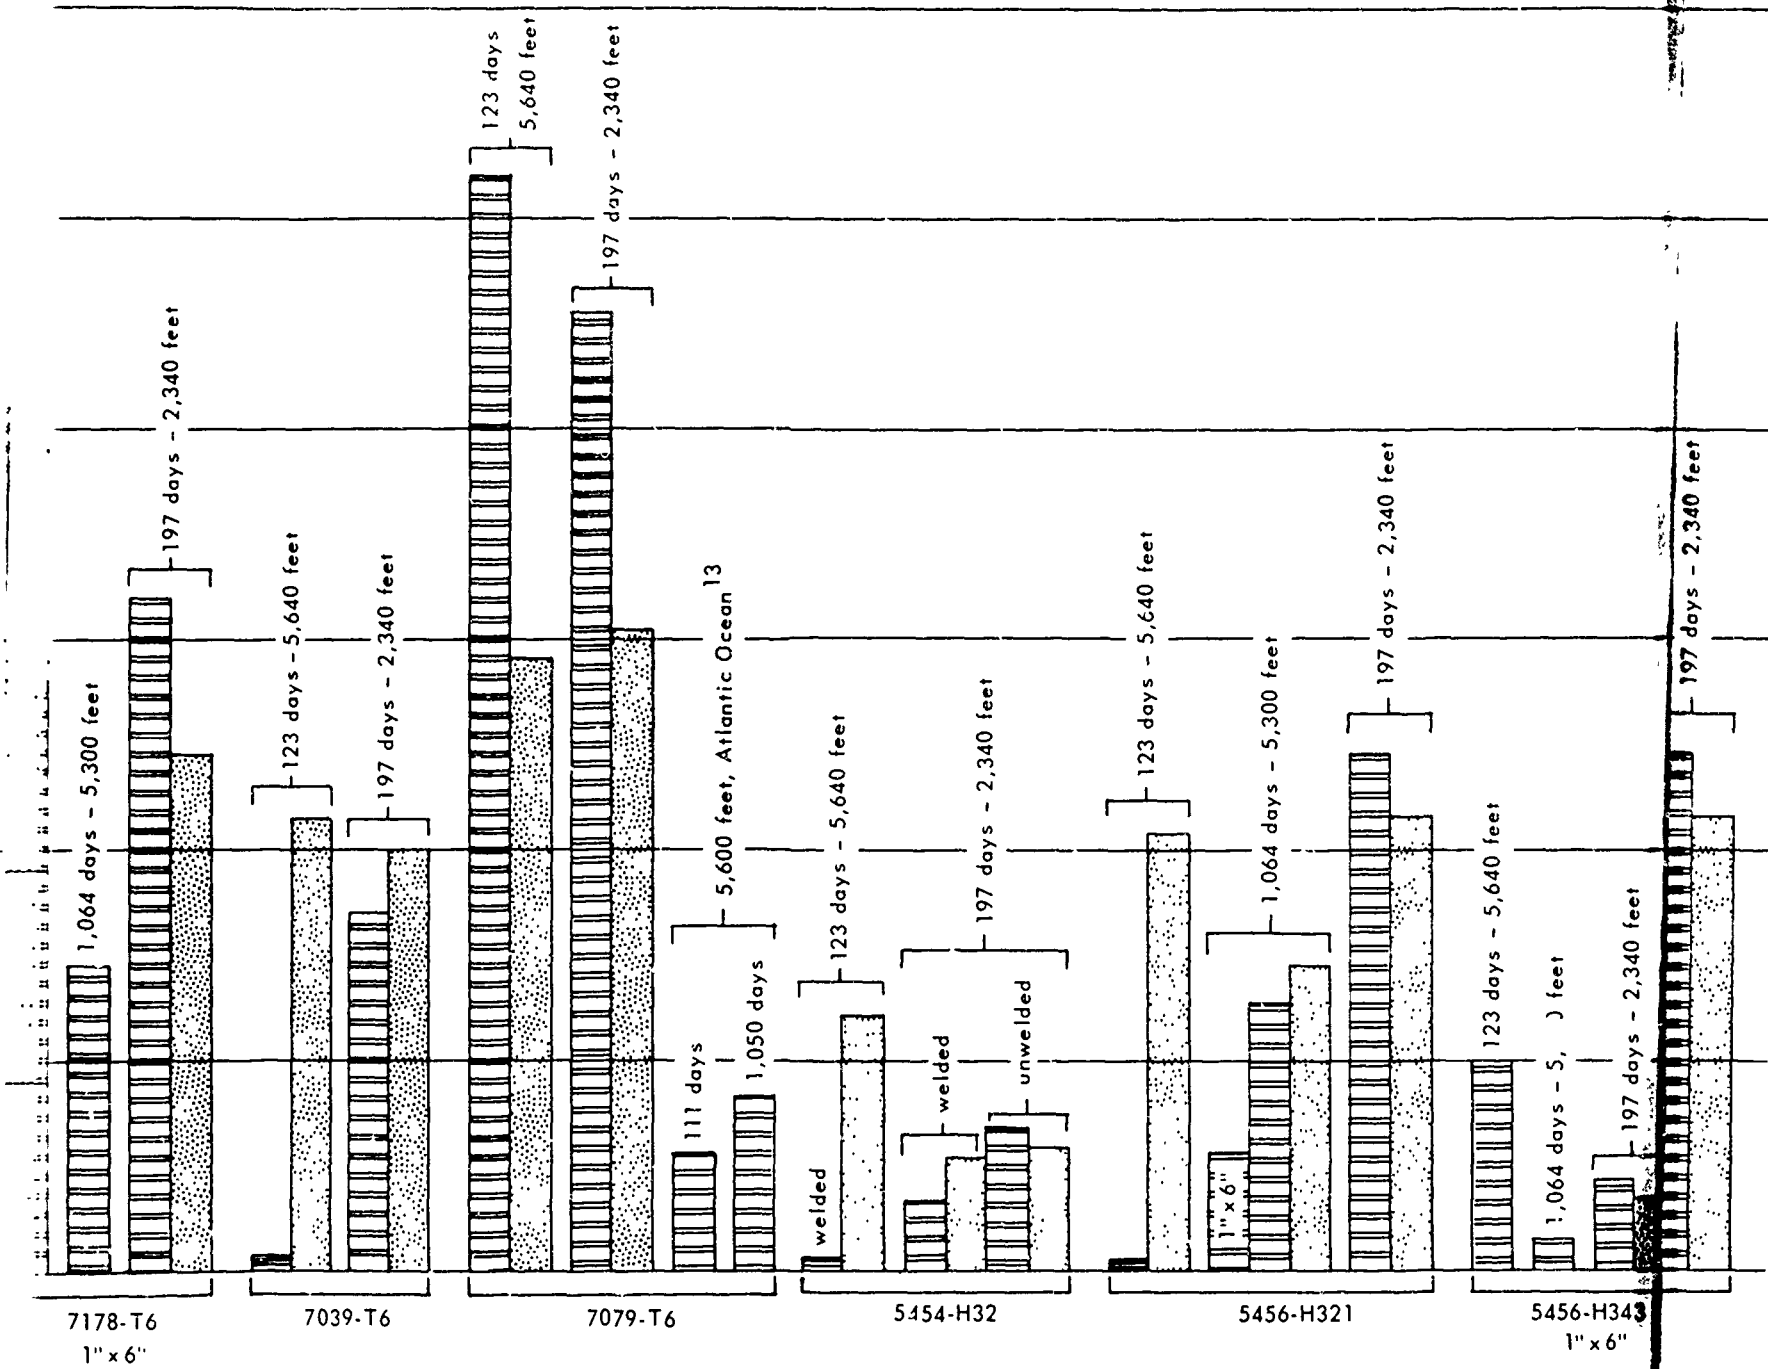
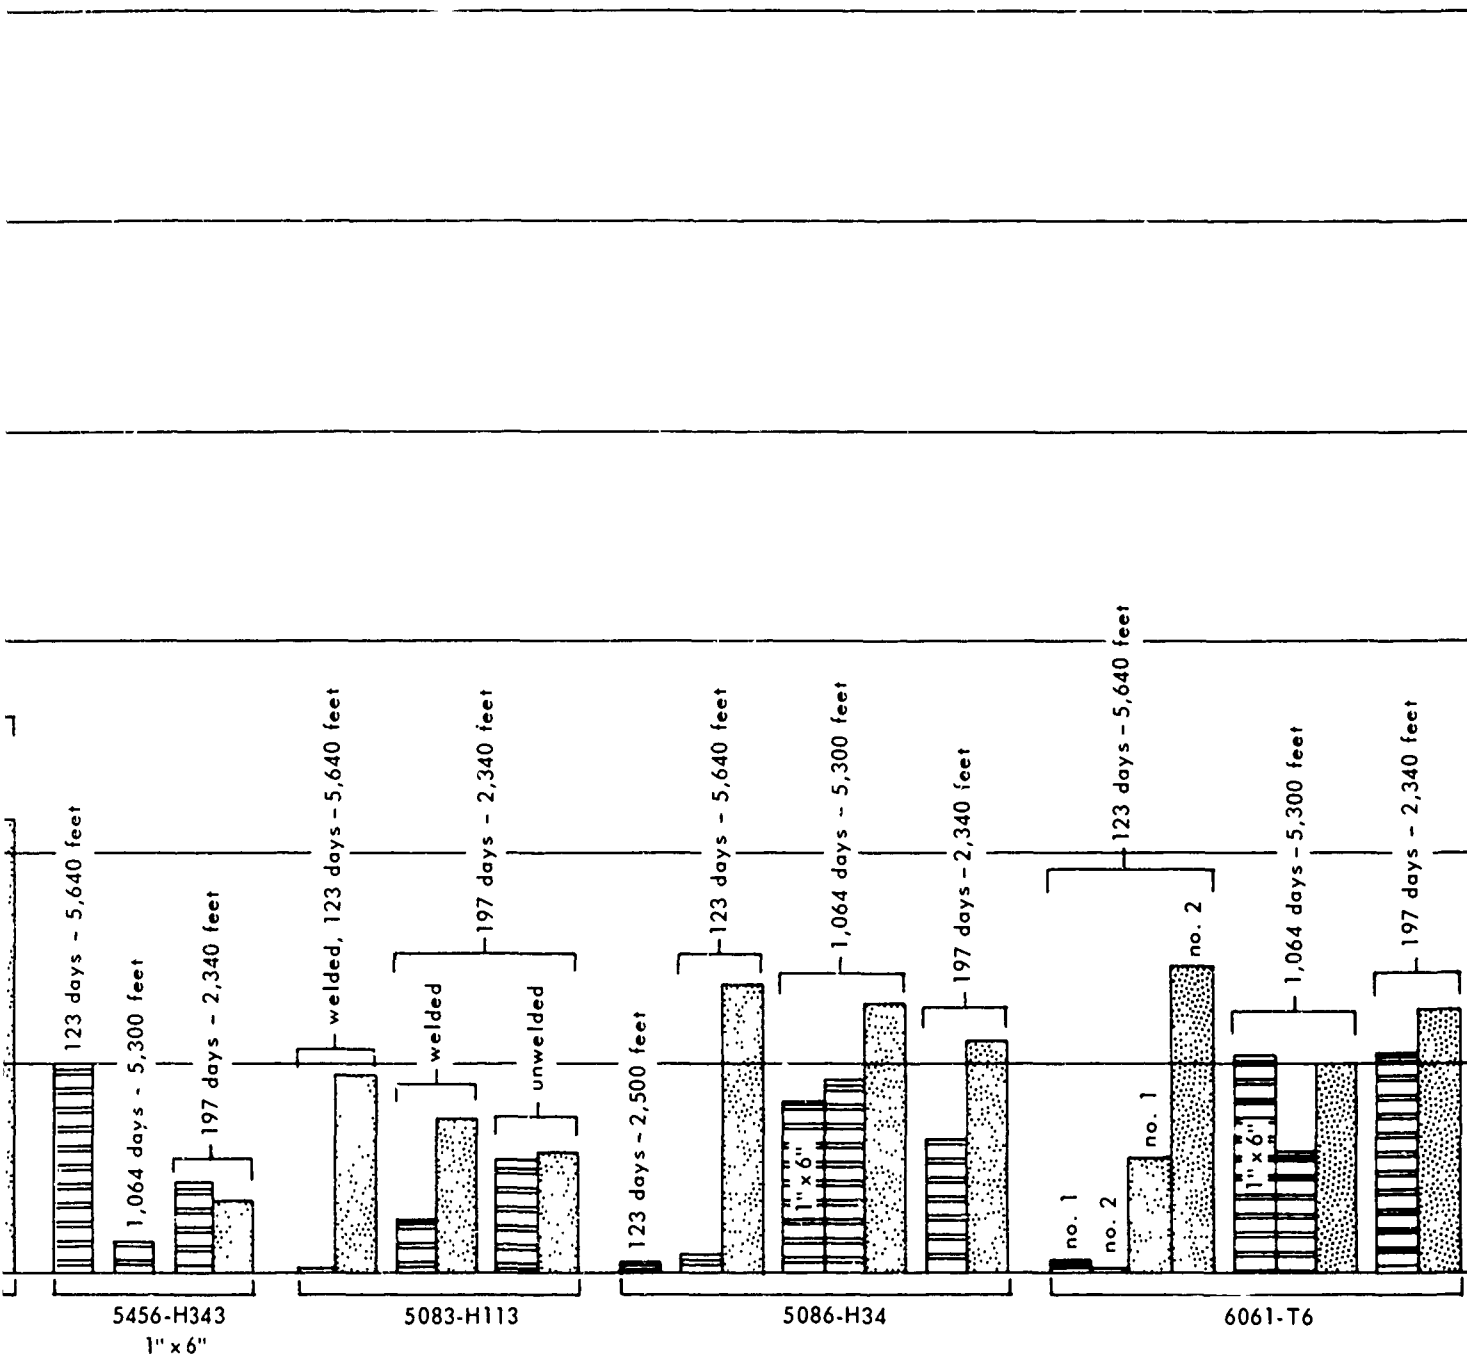
Figure 30. Corrosion rates of aluminum alloys in the deep ocean (the Pacific Ocean unless otherwise specified)

The corrosion rates of the alloys after different periods of exposure at depths of 2,340, 5,300, and 5,640 feet are shown in Figure 30. The corrosion rates of aluminum alloys 3003-H14, alclad 3003-H12, 5456-H321, 5086-H34, and 6061-T6 exposed in the water increased with time at a nominal depth of 5,500 feet, but those of alloys 2219-T81, 7178-T6, and 5456-H343 decreased with time. The corrosion rate of alloy 3003-H14 partially embedded in the bottom sediment increased with time, but the corrosion rates of 2219-T81, alclad 3003-H12, 5456-H321, 5456-H343, 5086-H34, 6061-T6, and 7178-T6 decreased with time.

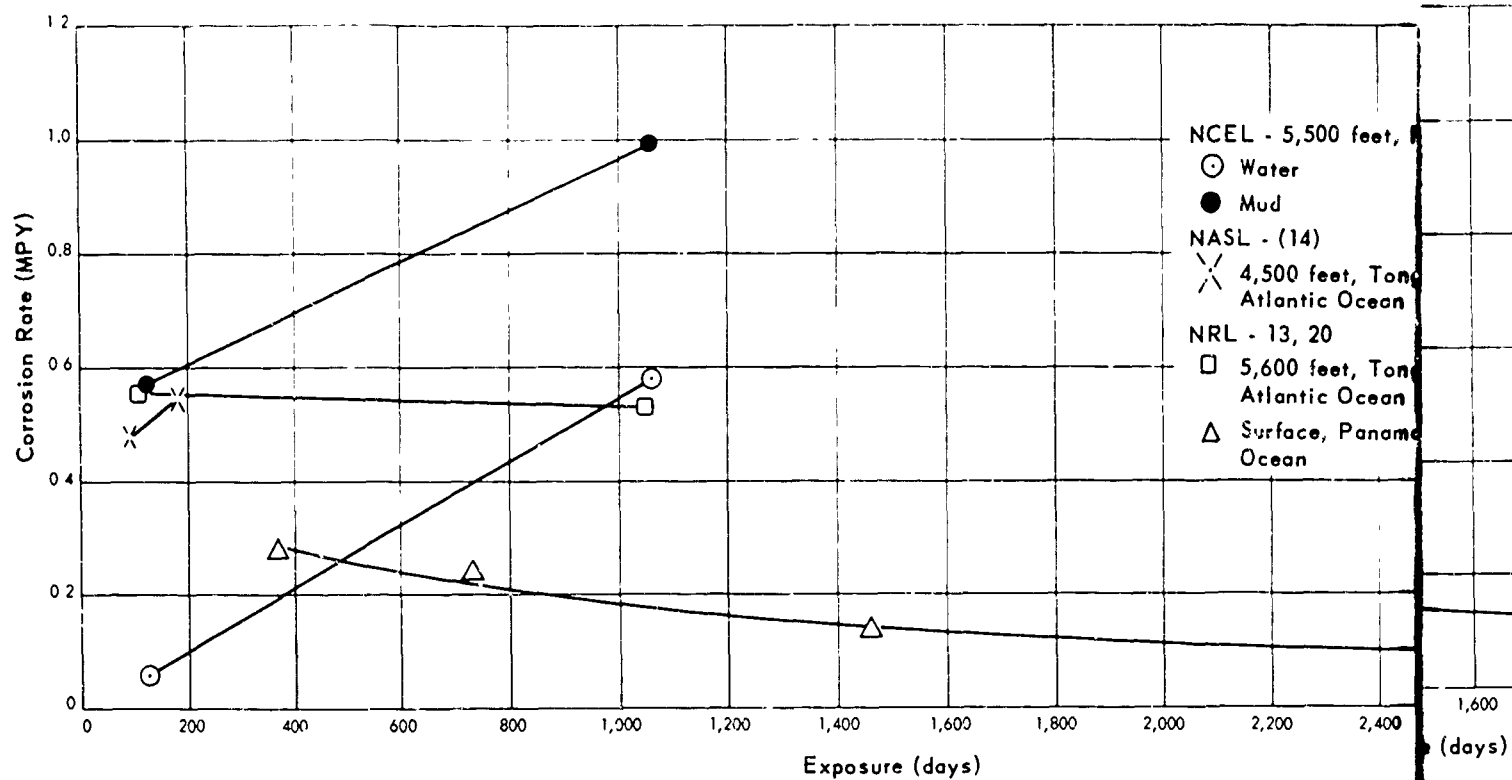
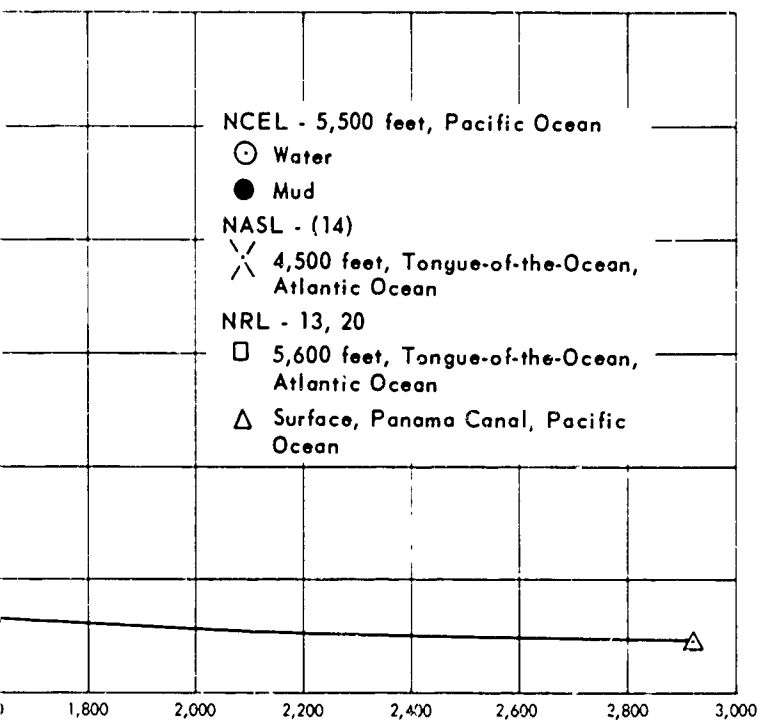
Figure 31. Corrosion of 6061-T6 in different localities.

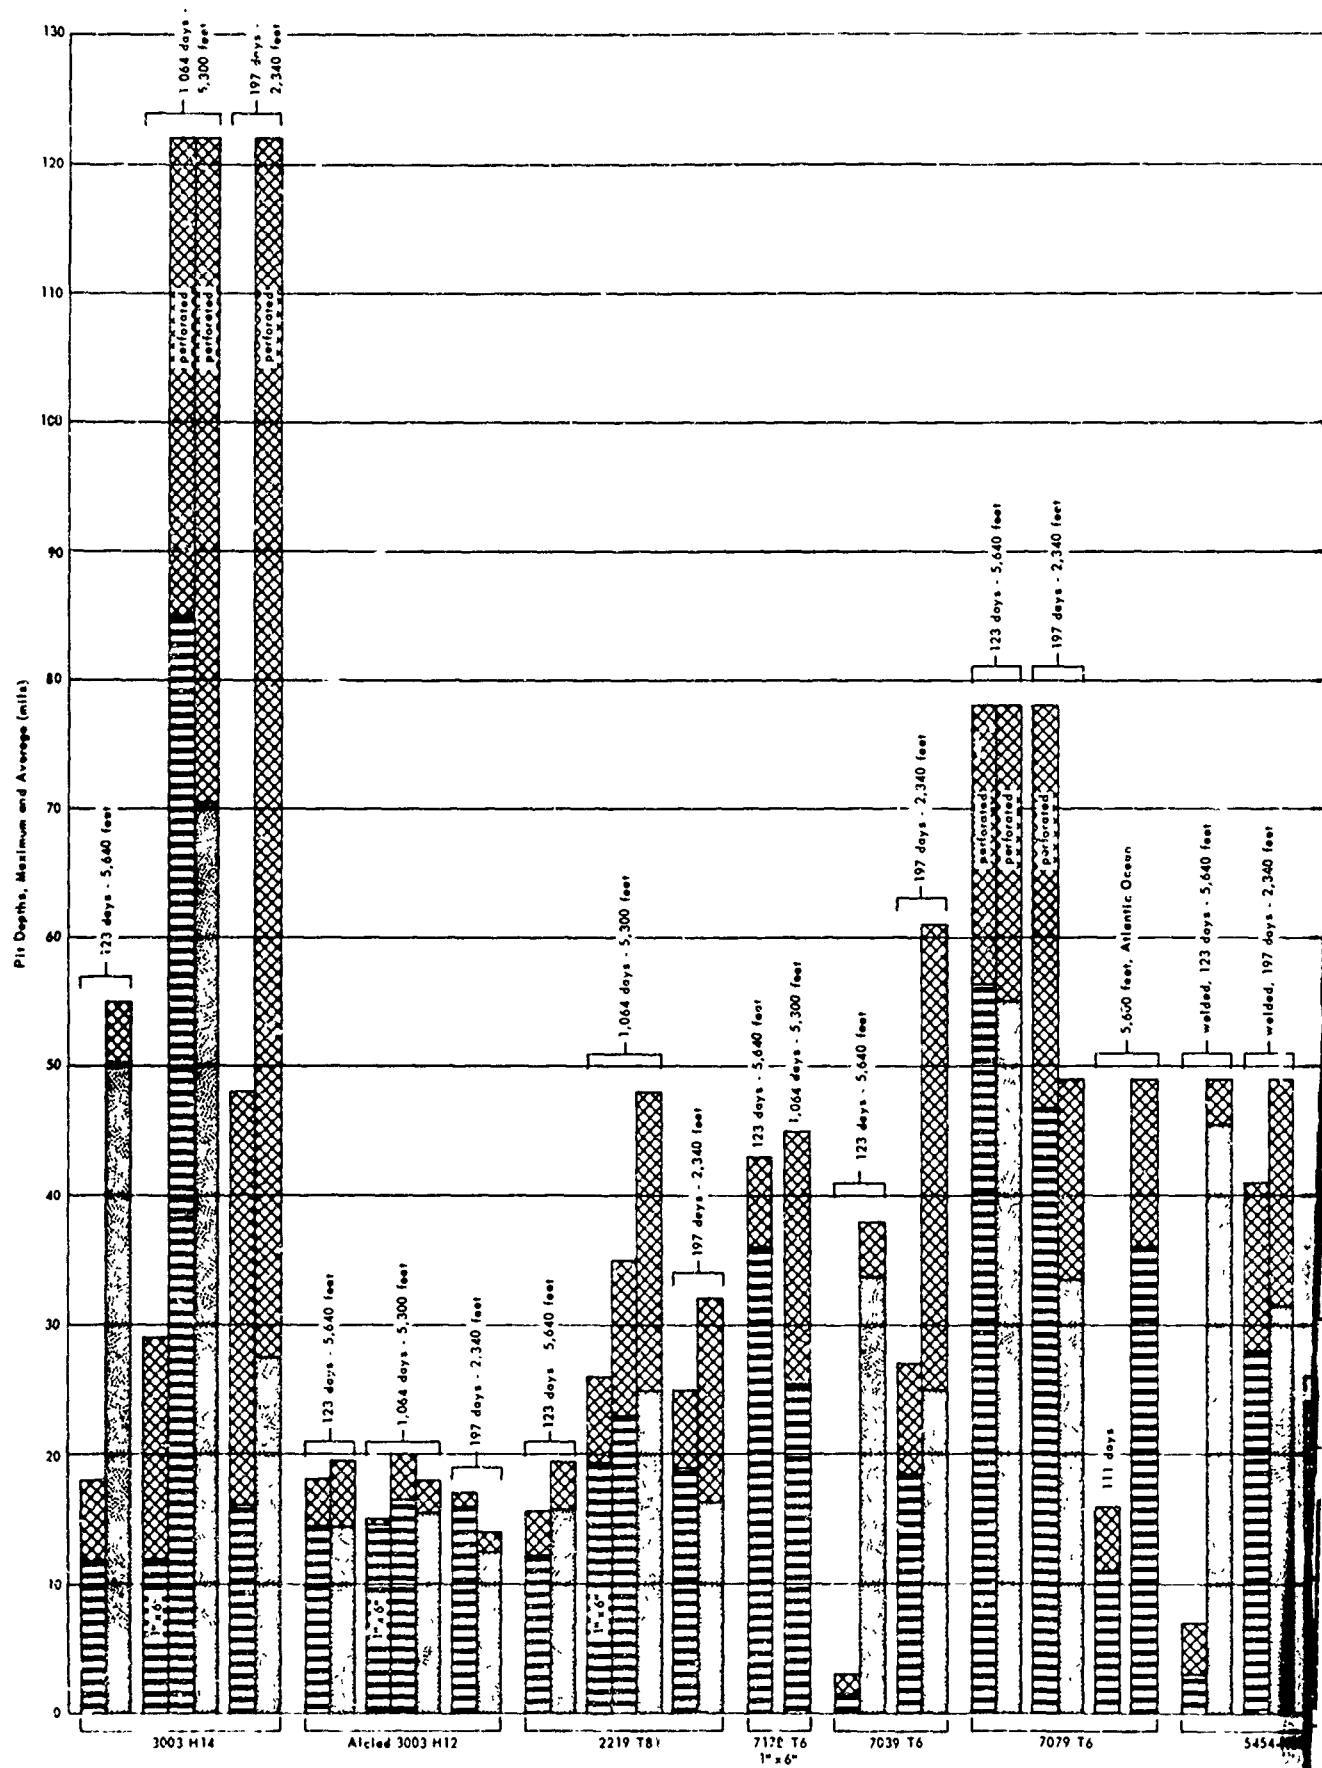
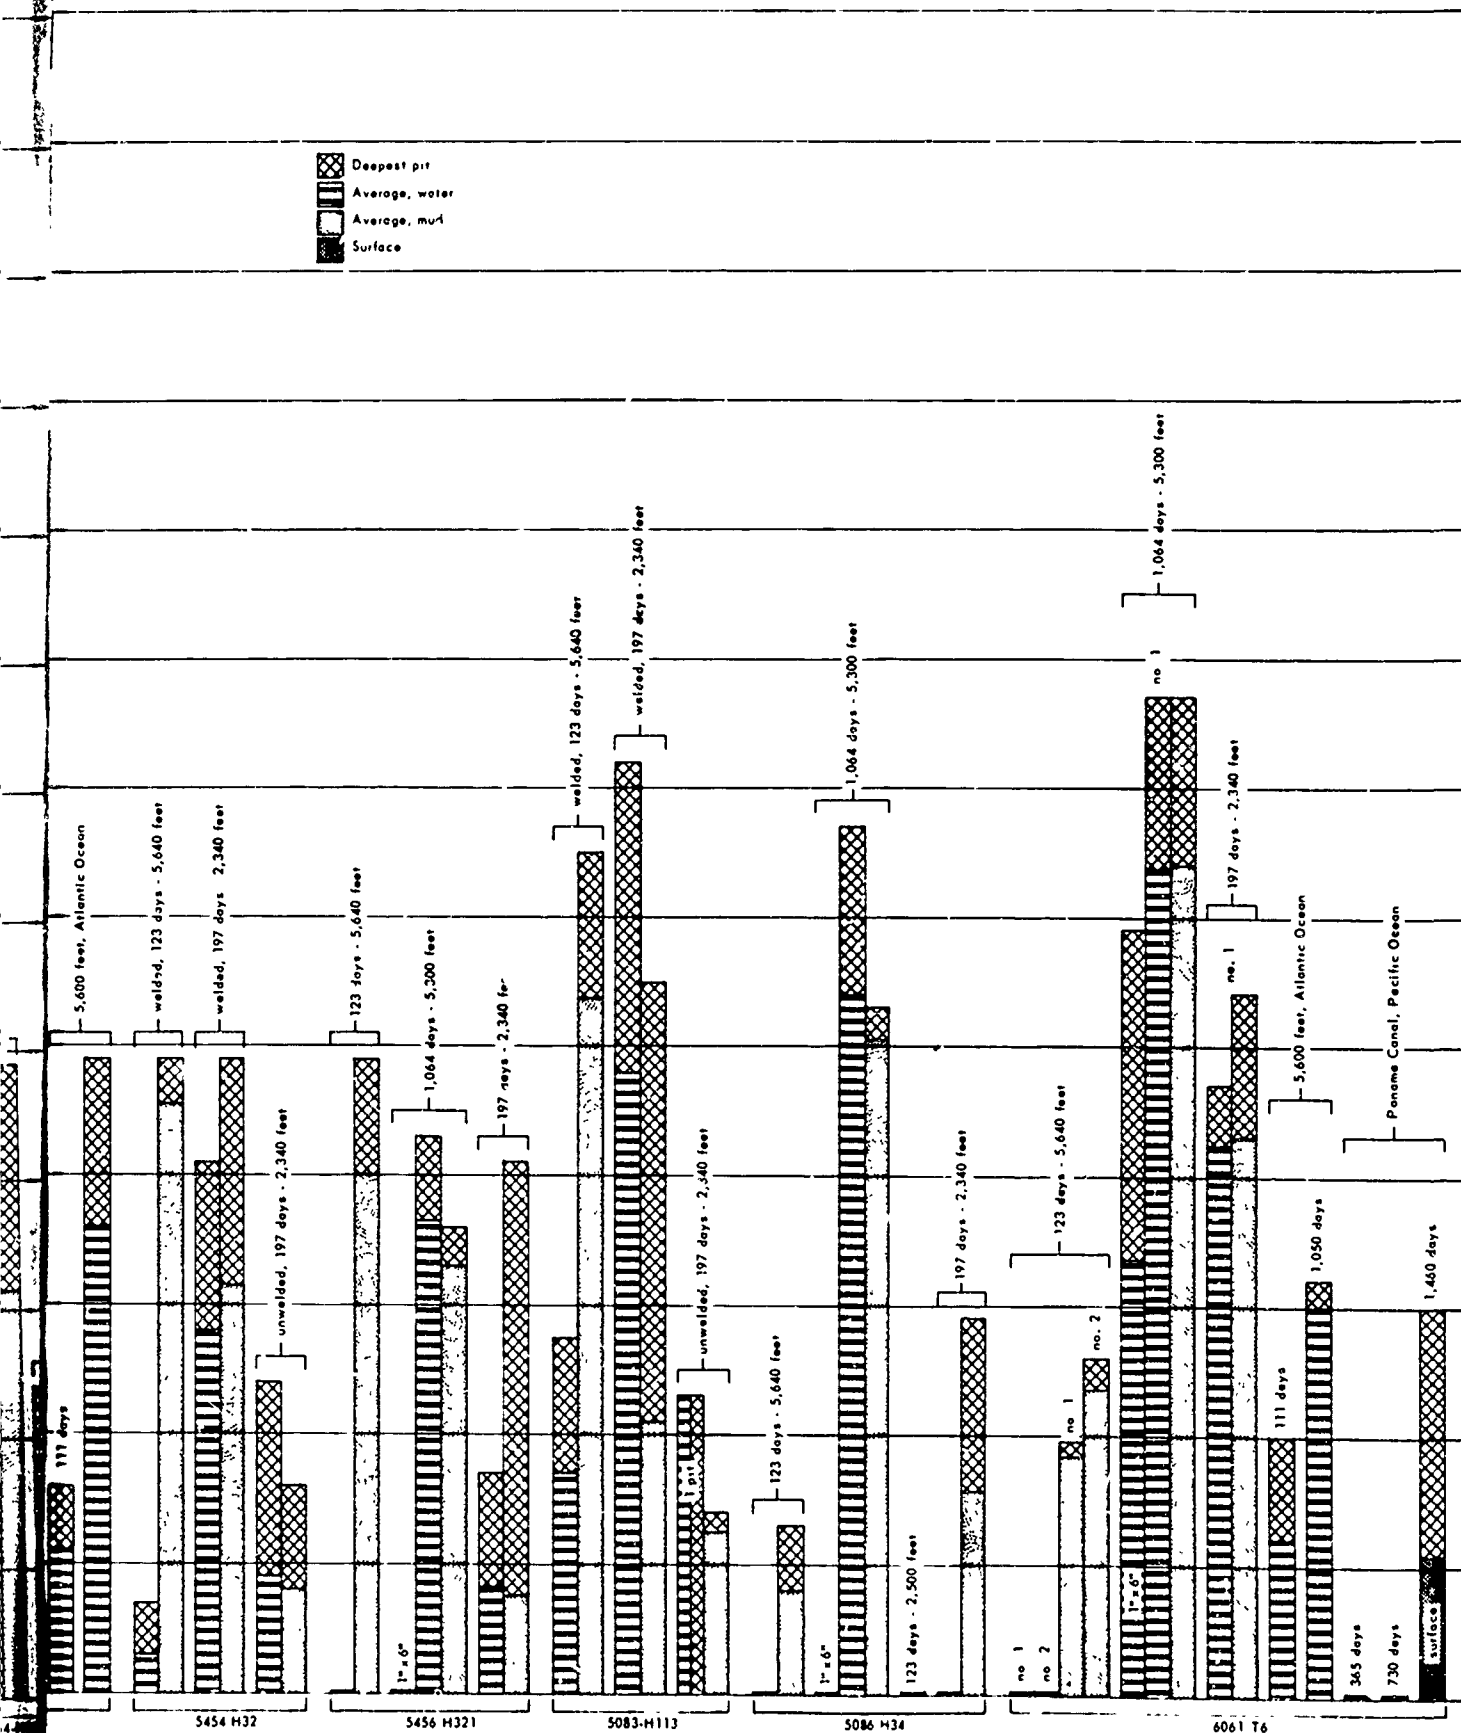
Figure 32. Pitting of aluminum alloys.

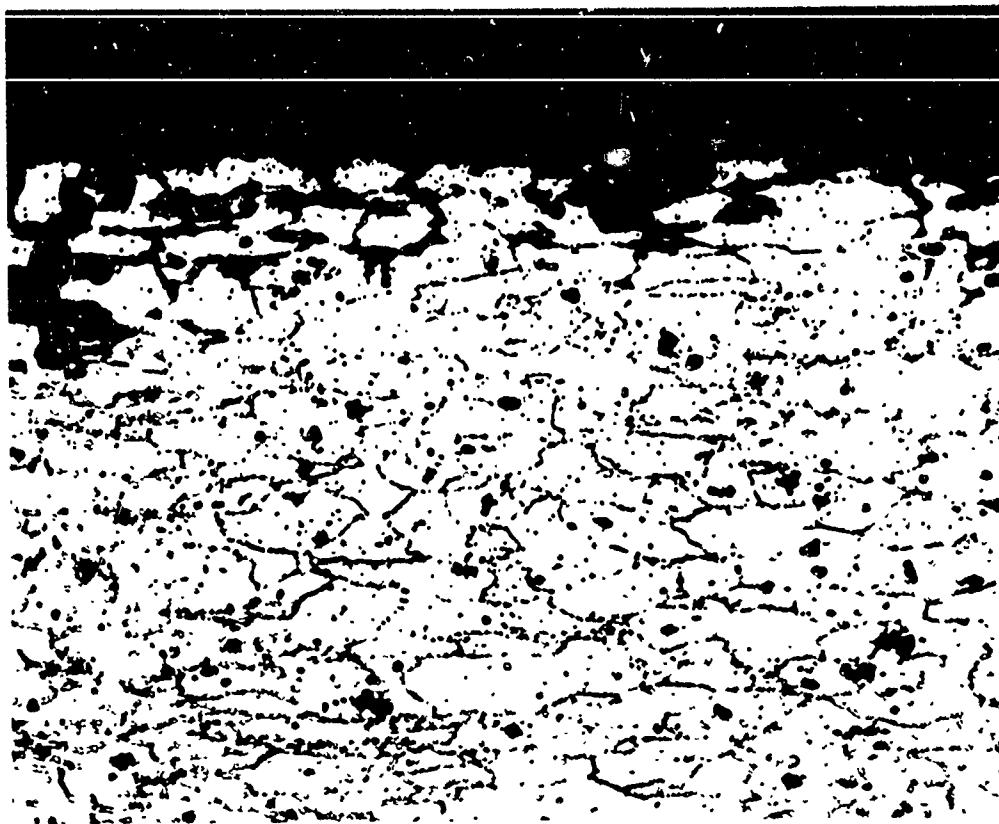
Figure 33. Intergranular corrosion in 5086 -H34 alloy. Keller's etch; X500.

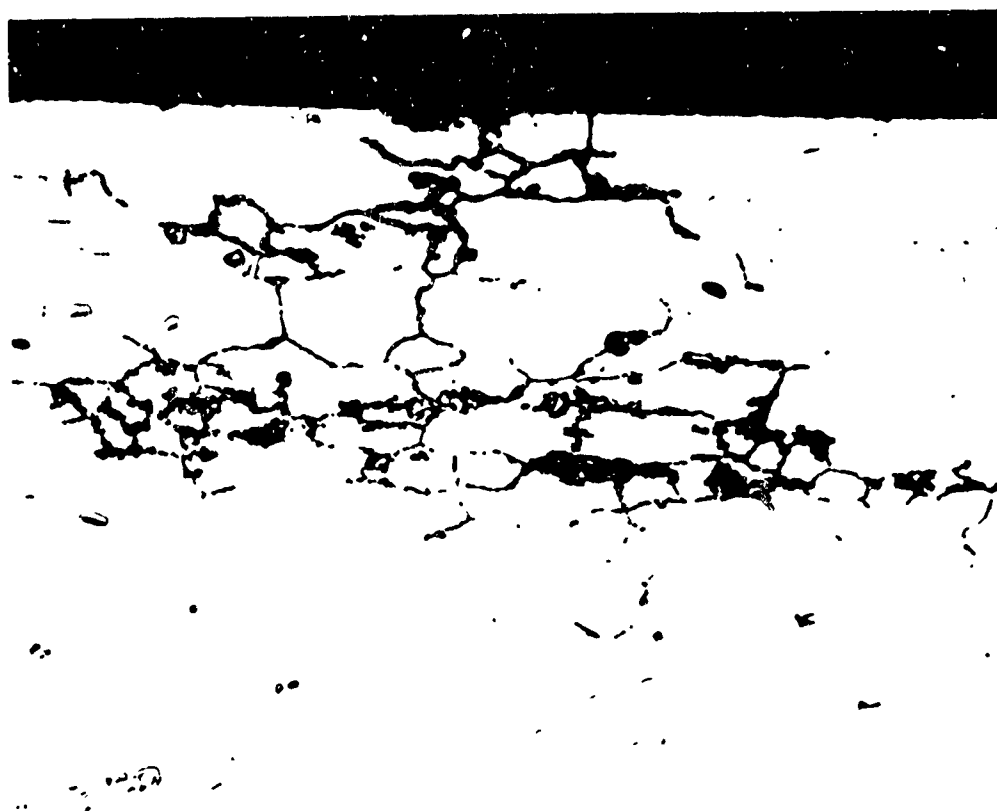
Figure 34. Intergranular corrosion in 6061 -T6 alloy. Unetched; X500.

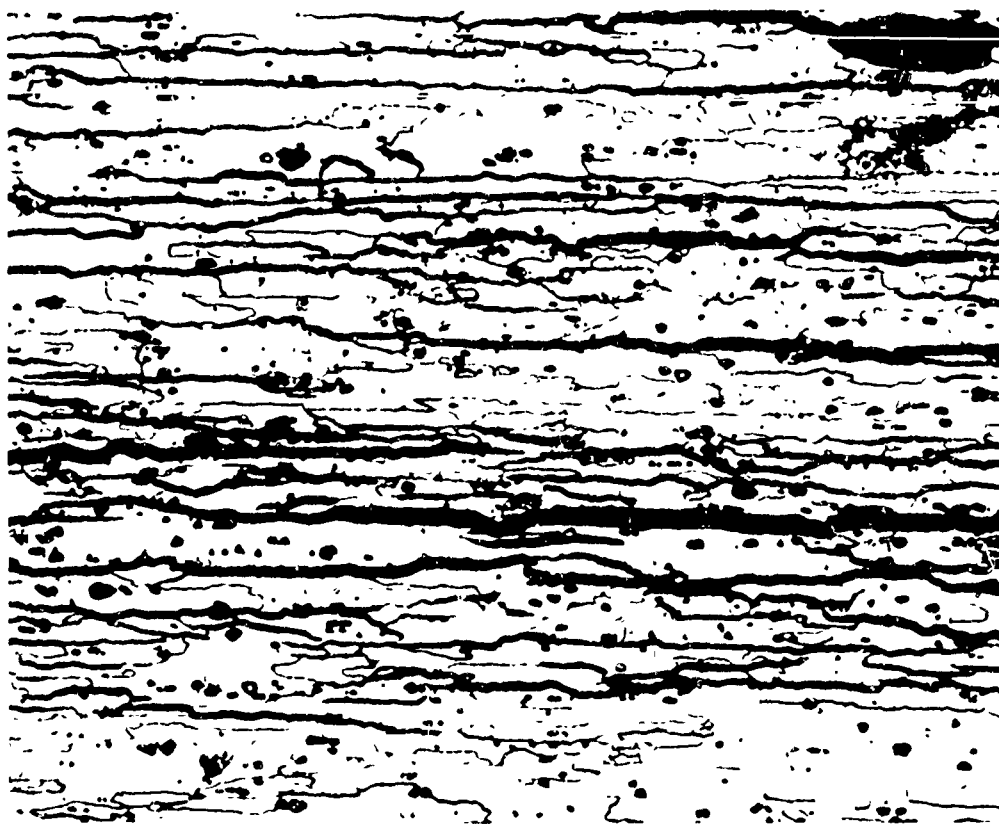
Figure 35. Exfoliation type of intergranular corrosion in 7178-T6 aluminum alloy. Keller's etch; X200.

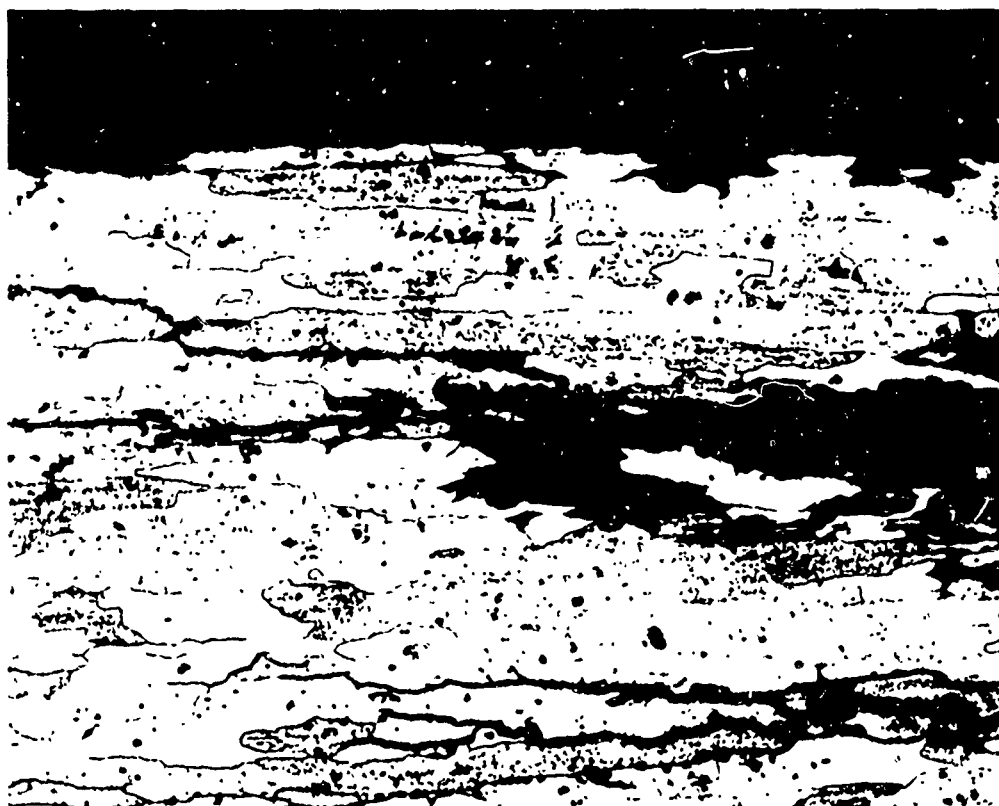
Figure 36. Exfoliation type of intergranular corrosion in 7039-T6. Keller's etch; X200.

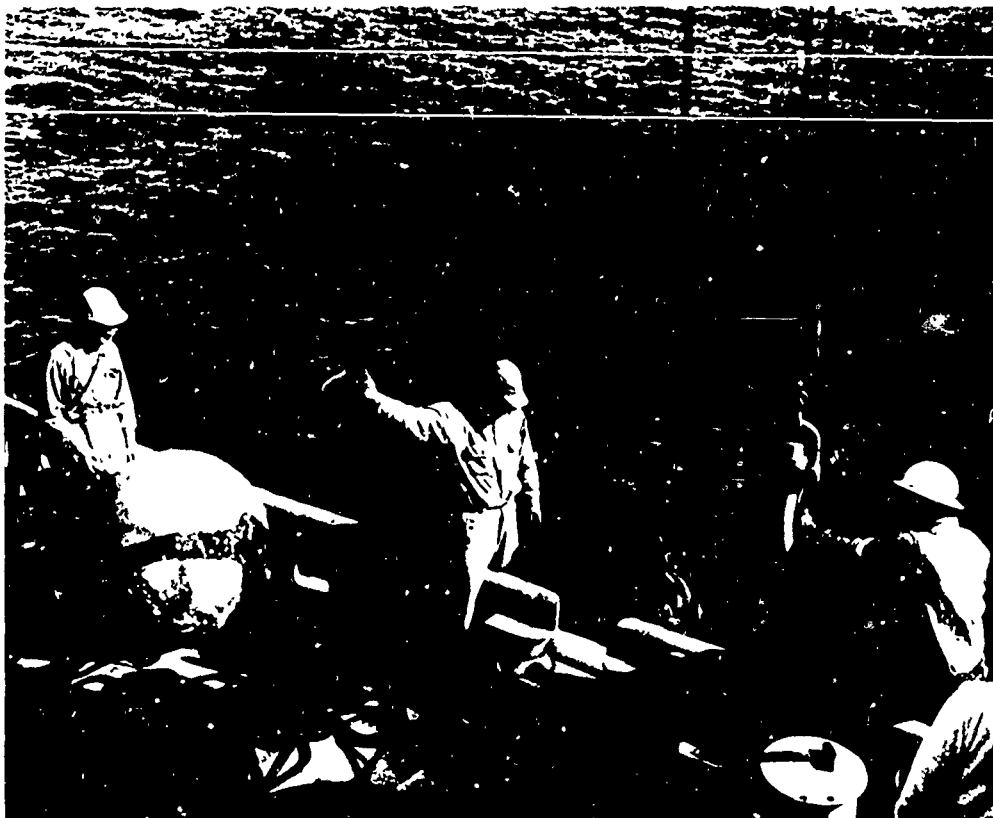
Figure 38. Alclad 7178-T6 buoy after recovery on board ship.

A practical case of line corrosion on an aluminum alloy was encountered with the alclad 7178-T6 aluminum alloy buoys used in the installation of the STU structures. During the retrieval of STU 1-3 after 123 days of exposure, the buoy, which was 500 feet below the surface, was found to be corroded (Figure 38). The white corrosion products on the bottom hemisphere cover areas where the alclad layer had corroded through to the core material. The top hemisphere was blistered, the blisters being as large as 2 inches in diameter and 0.75 inch high. One of these blisters is shown in Figure 39. The hole in the top of the blister indicates the origin of the failure: originally a pinhole in the cladding where seawater gained access to the interface between the cladding alloy and the core alloy. When this blister was sectioned to inspect the corrosion underneath, it was found to be filled with white crystalline aluminum oxide corrosion products (Figure 40). It appeared that seawater penetrated the alclad layer at a defect or at a particle of a cathodic metal (iron), and the corrosion was then concentrated at the interface between the two alloys. The thickness of the remaining alclad layer indicated that it had not been sacrificed to protect the core alloy as was its intended function. On the other hand, the selective corrosion of the alclad layer on the bottom hemisphere and the uncorroded core material showed that, in this case, the cladding alloy was being sacrificed to protect the core material as intended.

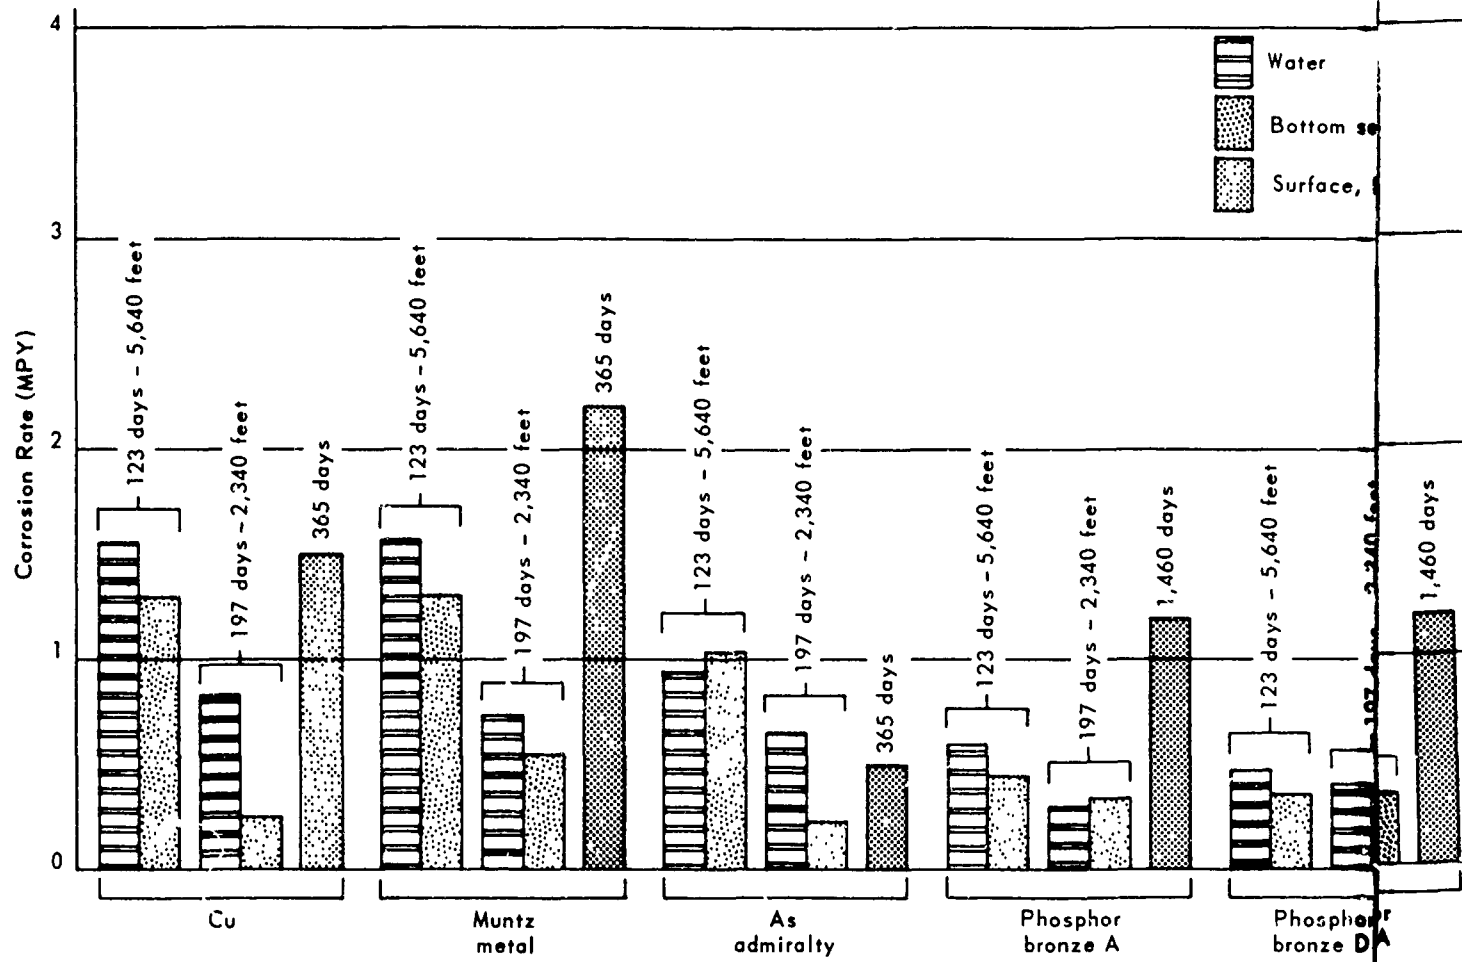
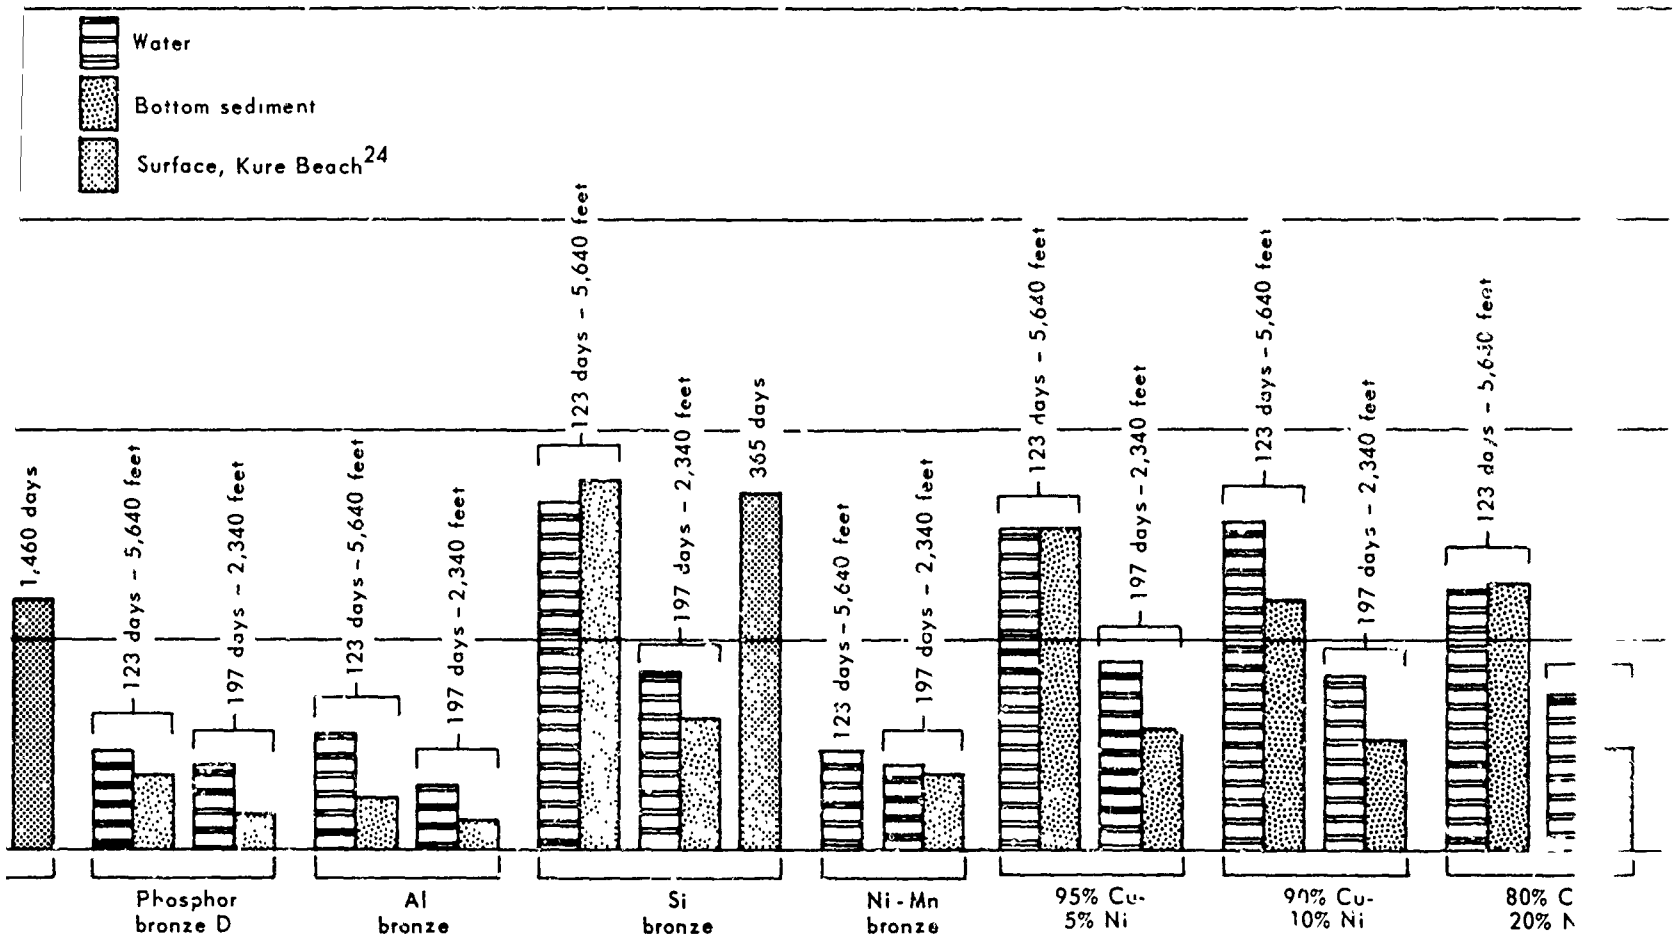
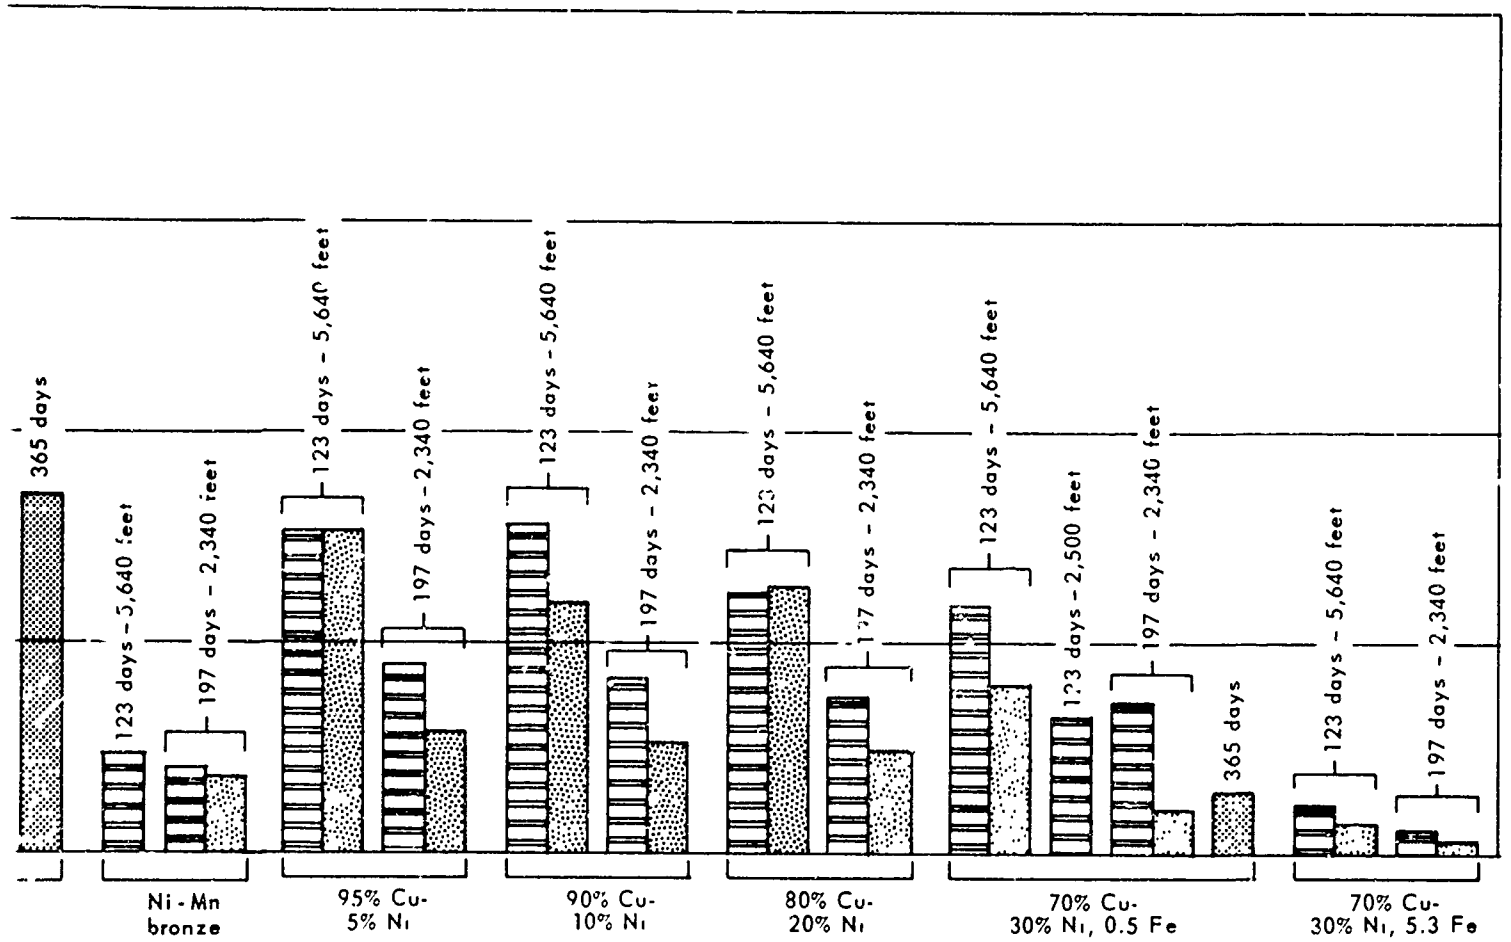
Figure 43. Corrosion of copper alloys.
